High Resolution Computed Tomography Inspection of Components Uncovers Root Causes of Vexing Failure Mysteries

Michael R. Johnson*

Insight Instrument Deployment Arm (IDA) Motor Winding Anomaly

10 mm Motor/Gearbox Life-Test-to-Failure Determination of Failure Source

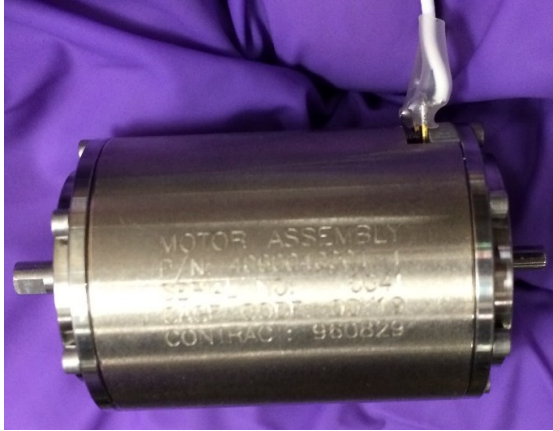
The IDA is exposed directly to the environment of Mars and experiences large changes in temperature from day to night. This thermal cycling can have deleterious effects on assemblies composed of materials with different coefficients of thermal expansion. To demonstrate the capability of the motors, a thermal cycle test was performed on three units. To establish design margin, the number of test thermal cycles is much larger than the quantity of cycles during the mission. This type of thermal cycle testing is considered a qualification test and the hardware is not flight worthy after going through the testing. For brushed motor assemblies, the adhesively bonded windings on the rotor and the winding terminations to the commutator are the primary thermal cycle sensitive items. There are also the bonds between the magnets and the housing and other ancillary areas that are also stressed during the thermal cycle testing. One of the three test motors, serial number 041 is shown in Figures 2, 3, and 4.

Figure 2. Motor Serial Number 041
Motor Diameter is 30 mm

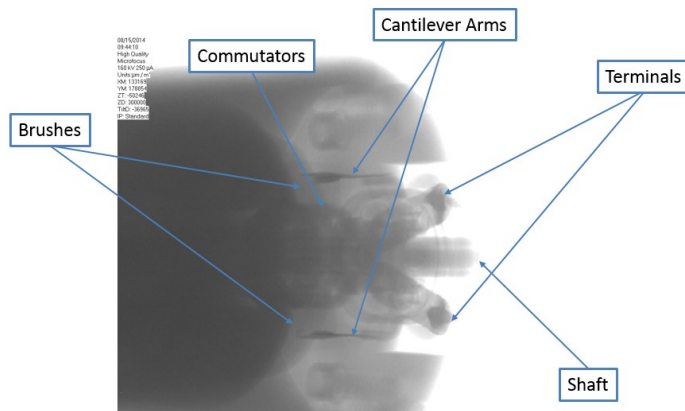
None of the inspection methods had indicated the actual source of the resistance changes. Some locations were implicated by the presence of cracks in the epoxy coating, but none of them showed any signs of a feature that would cause an increase in resistance as the temperature is reduced during the cold temperature portion of the thermal cycles. The solder joints at the commutator were inspected as well and, while some of the joints had workmanship issues, none of the connections showed any type of failure that would support the test data. The brush block/commutator/shaft assembly was X-Ray inspected while installed in the motor and the brush springs (cantilever arms) showed a proper preload on the brushes as indicated by the deflection of the spring arm (see Figure 11).

Figure 11. X-Ray Image of the Brush/Commutator Assembly

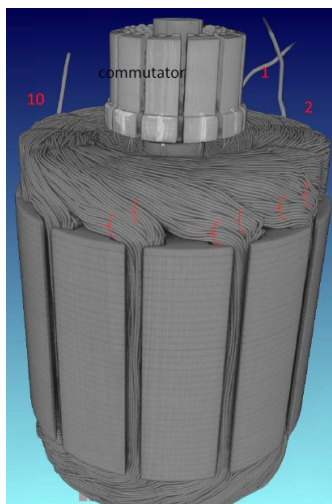
Overall CT Scan views of the rotor assembly are shown in Figures 12, 13, and 14. Figure 12 shows the rotor assembly with the individual winding wires clearly visible. Figure 13 is a cross-section of the rotor with one slot on the rotor exposed and the wires within the slot visible in fine detail. Figure 13 is a view of the brush assembly end of the shaft with the brushes and cantilever arms clearly visible.

Figure 12. Rotor Assembly

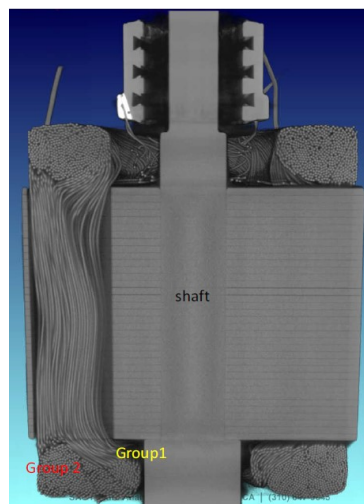
Figure 13. Section of Rotor Showing Wires in the Slot

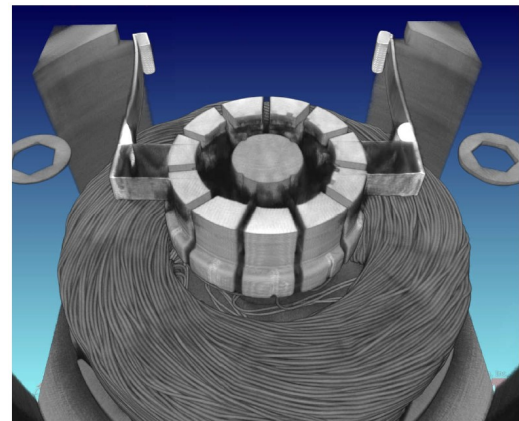
Figure 14. Brushes, Commutator, and Cantilever Arms

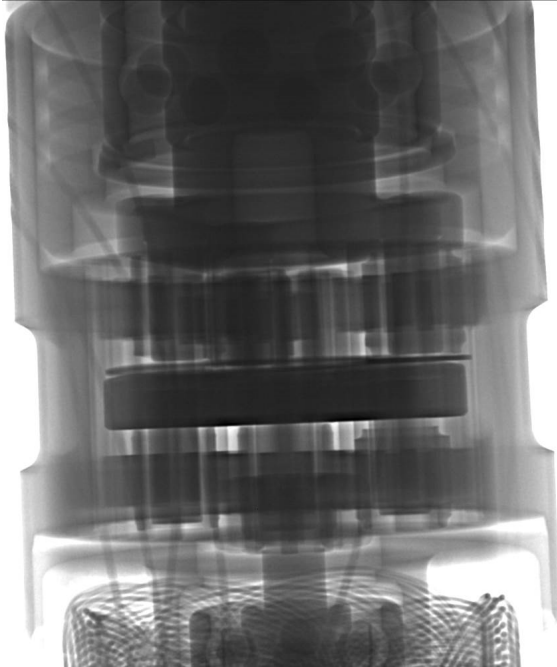
Figure 19. X-Ray Image Showing the Gearbox Section of the Actuator. Output Ball Bearings are at the Top of the Image and the Front Motor Bearing is at the Bottom

From the x-ray images there is no apparent problem within the actuator at all. The gearbox looks to be in good shape, the bearings at the gearbox output show no indication of extreme wear or debris, the motor bearings do not show any sign of wear or debris, and the motor windings show no indication of being damaged. The failure mechanism needed to be consistent with a wear phenomenon since the test required a slowly increasing drive current to keep the mechanism operating properly. This would indicate an increasing load torque as opposed to a sudden change. The only item detected with the x-ray images was the offset of the detent wheel from the detent stator. This appeared to be a manufacturing defect since it would not explain a slowly increasing load torque.

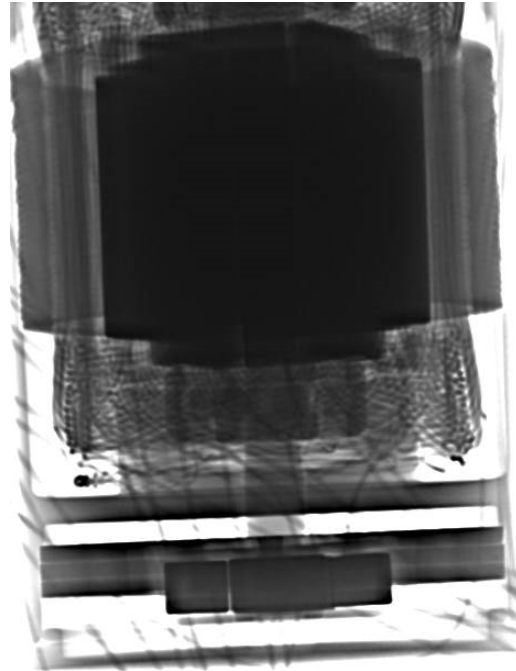
Figure 20. X-Ray Image Showing the Detent Magnet Section of the Motor Assembly. Magnets are on the Rotor and the Teeth are on the Stator

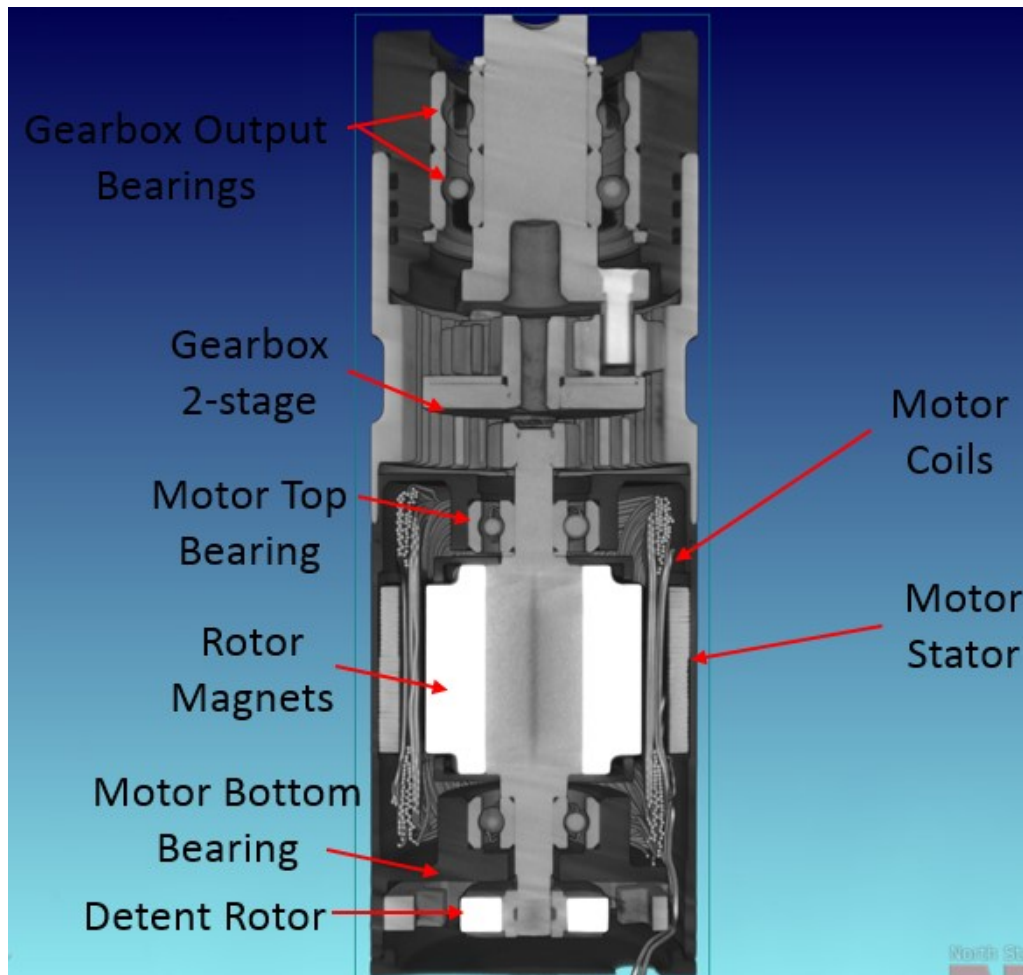
Figure 21 shows the overall view of the motor and gearbox assembly for the 10 mm actuator. The CT Scan detailed computer model allows the cross-sectioning of the image so internal components can be inspected. In this actuator, the planetary gear faces are one millimeter wide. The bright portions of the image are the permanent magnets due to their high density. Figures 22 and 23 show the planetary gear stages in a cross-section of the computer model at each stage location. No debris is visible and no wear

of the gear tooth form is evident from the image. The gear teeth and tooth form look as if there is no wear at all. The input to the first stage of the planetary gears had been through 258 million revolutions at this point.

Figure 21. Overall Image Cross-Section of the 10 mm Actuator Assembly

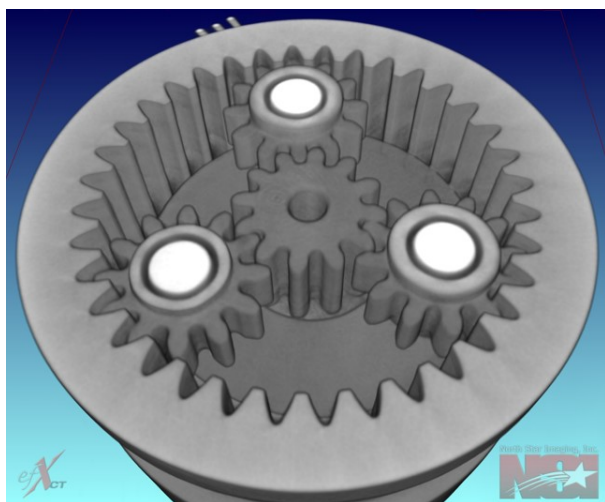
Figure 22. Second Planetary Gear Stage

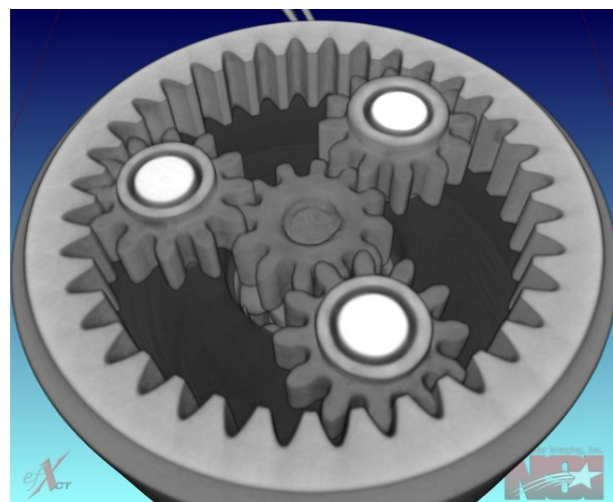
Figure 23. First Planetary Gear Stage with the Motor Pinion at the Center

The view of the first stage of the planetary gears seemed to show an offset of the pinion gear toward the motor. This necessitated an inspection of the front motor bearing. Looking at a section of the model from the side in Figure 24 shows that the motor bearing appears to have shifted downward in the image and the motor pinion gear has done the same. Scrutinizing the bearing assembly itself shows no unusual wear or debris. All other elements of the motor assembly in this region seem fine.

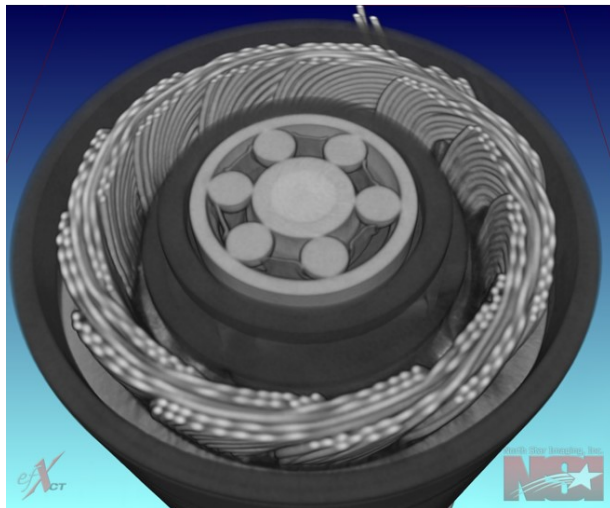
The offset of the rotor was a mystery and required further investigations. Looking at an isometric view of the section of the motor through the shaft at the front motor bearing did not expose anything unusual. Figure 25 shows the view with the front motor bearing fully intact with no significant wear or debris.

Figure 25. Front Motor Bearing Closest to the Gearbox Input

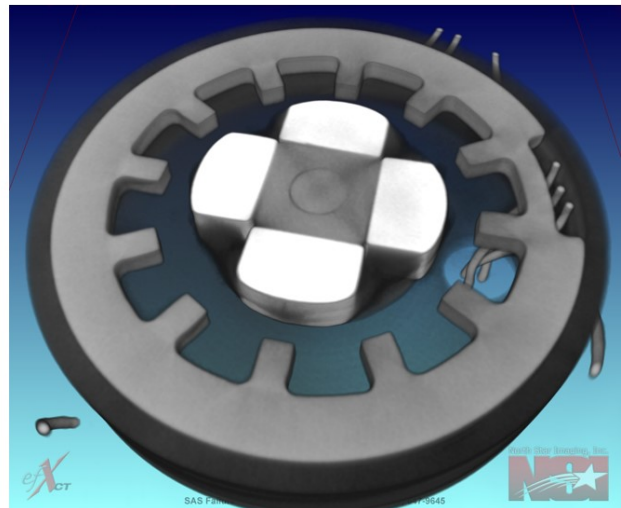
Moving down to the rotor detent assembly, the detent magnets are positioned properly within the inside diameter of the detent stator and no anomalous behavior appears at this location. Figure 26 shows this region of the motor assembly with no visible indication of a torque drag anomaly.

Figure 26. Detent Rotor and Stator

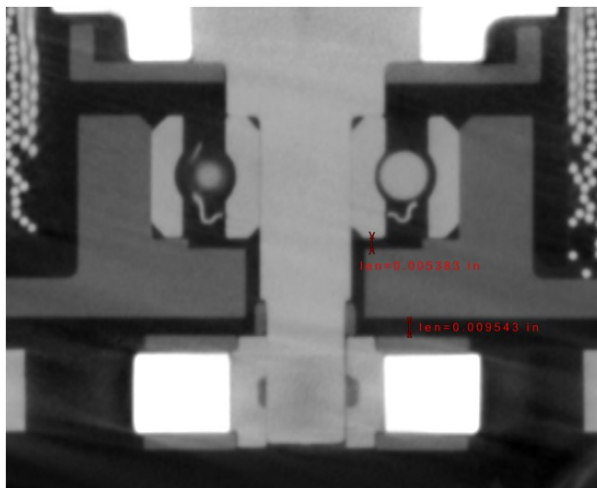
Closer inspection provided the needed clues to the solution. The shaft in the bore of the bearing in figure 27 appears to be smaller than the bore. Figures 28 and 29 show a side-by-side comparison of the end of the motor with an as-built beginning of life motor on the left and the failed life test motor on the right.

Figure 28. Healthy Motor at the Beginning of Life Showing Bearing Placement and Shaft Fit. The measurements in the images are in inches (0.0095 in = 241 microns)

Lastly, making the rotor free to rotate within the motor bearing bores, if possible, provides a robust and graceful degradation path for actuator motors. This is especially important at the lowest torque location within the mechanism – the motor rotor.
